ALLSAFE HOME INSPECTION SERVICE, INC.  
102 N. Water Street,  
East Bridgewater, MA 02333  
508-378-7170

## FINAL NARRATIVE REPORT

Wood framed colonial reproduction, with attached 2-car garage. (See Photo #1)

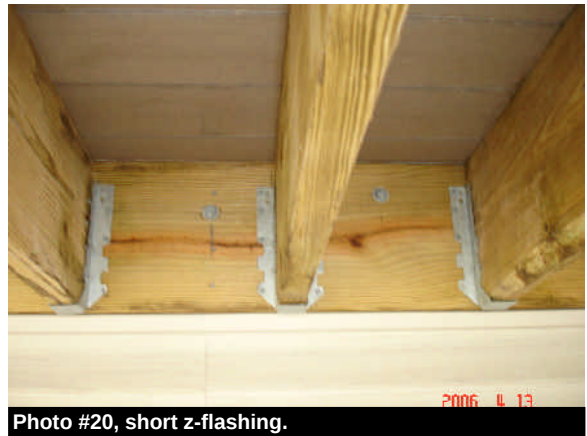
Photo #20, short z-flashing.

A. Observation: As seen beneath the deck, the metal z-flashing installed beneath the vinyl siding and over the top edge of the horizontal ledger joist, does not fully lap and bend over the edge of the ledger joist. (See photo #20)

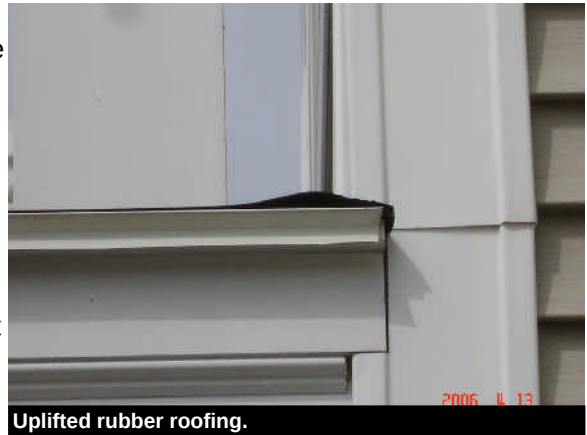
Uplifted rubber roofing.

Recommendation: Hire a roofing contractor to cement the edge of the rubber roof covering to the roof decking as required. Monitor the roof drainage.

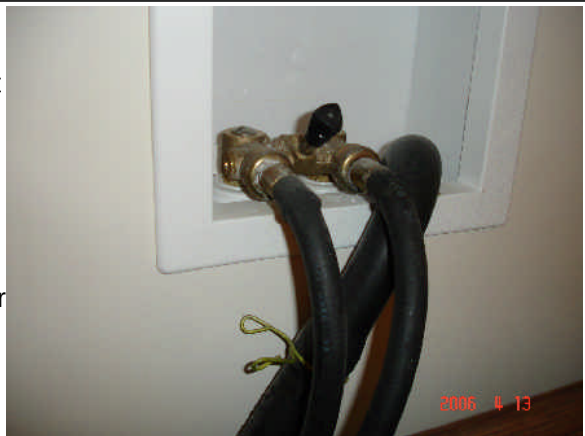
(Note: Insurance companies recommend that all washing machine hoses be replaced every five years regardless of type.)
