ALLSAFE HOME INSPECTION SERVICE, INC.  
102 N. Water Street,  
East Bridgewater, MA 02333  
508-378-7170

## FINAL NARRATIVE REPORT

Wood framed colonial reproduction, with attached 2-car garage. (See Photo #1)

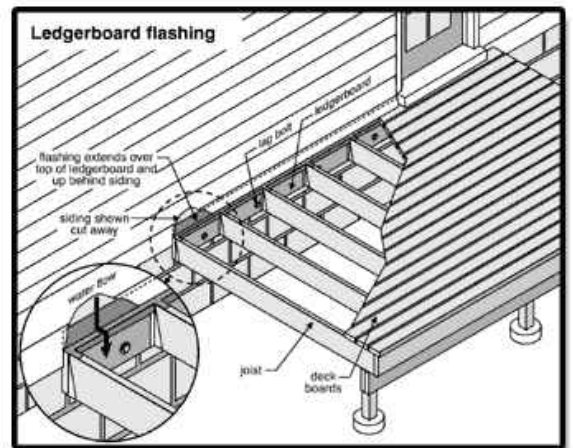
Photo #20, short z-flashing.

A. Observation: As seen beneath the deck, the metal z-flashing installed beneath the vinyl siding and over the top edge of the horizontal ledger joist, does not fully lap and bend over the edge of the ledger joist. (See photo #20)

Analysis: This problem is indicative of poor workmanship. The z-flashing should lap the edge of the ledger joist to prevent water from leaking behind the ledger joist and siding. Repair is suggested.

Recommendation: I advise that you hire a carpenter to improve the flashing workmanship. (See illustration above)

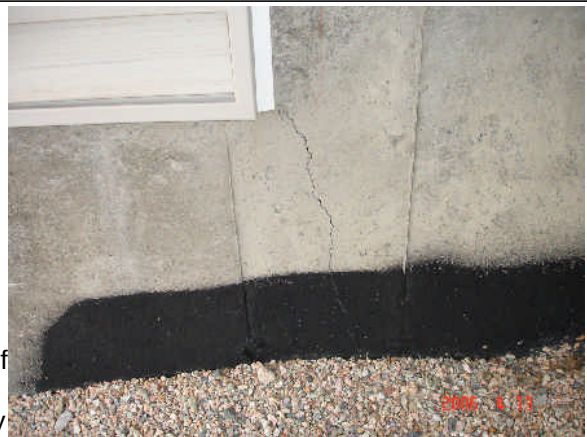
Analysis: In my opinion, such thin cracks are not of a critical nature and are typically categorized as "shrinkage cracks" caused by the introduction of water during the mixing and pouring of the concrete. Cracks of this type usually occur during the first year of construction and pose no significant risk to the structure. Be advised that hairline cracks are still candidates for low priority repairs as they pose a risk of allowing water infiltration, radon gas entry or insect access. There is a potential that additional cracks may exist behind storage in the basement or finished surfaces.

Recommendation: I advise that you hire a professional concrete repair company to fix all foundation cracks by epoxy injection and that you seek a written warranty. Once repaired, the cracks should be monitored for unpredictable future movement as cracks are time related. (See photo #19)

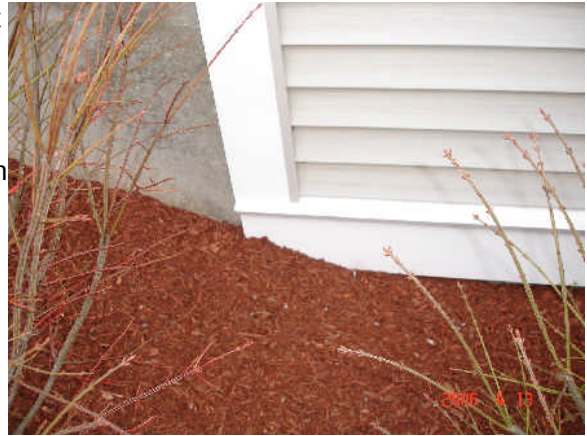
Analysis: This condition can lead to wood boring insect infestation / damage and / or wood rot. Be advised that closer inspection or exploratory demolition may reveal hidden decay or infestation within the wall frame or siding that was not disclosed in this report. Note: There is a potential for concealed damage. Be advised that any source of water penetration or ventilation imbalance can cause interior damage and / or mold.

Recommendation: The clearance between the earth and the siding should be corrected with a 6 inch minimum space as required. Improve the landscaping as required to fix clearance dimensions while still maintaining gravity flow for water removal away from the foundation.

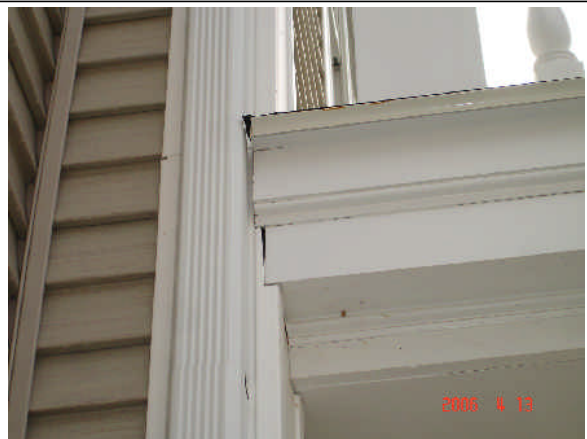
Analysis: This problem is conducive for water infiltration and decay. Maintenance repair is needed.

Recommendation: Caulk and seal all joints as required. Apply "stain-kills" to the knots and paint the trim boards. (See photo #29)

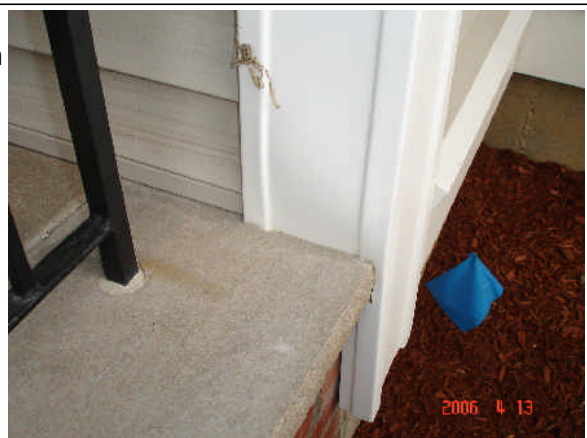
Analysis: Vinyl siding and trim need clearance for expansion and contraction.

Recommendation: Trim the bottom edge of each front outside corner.

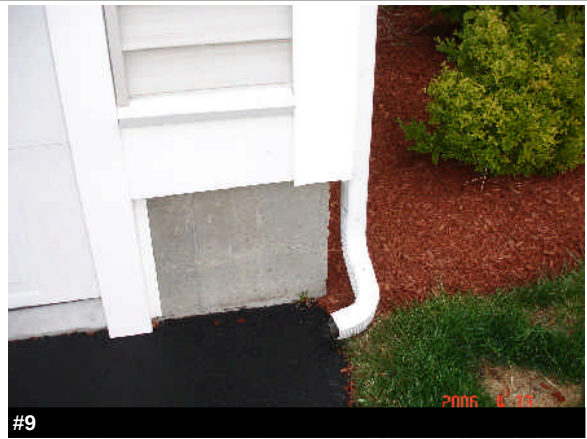
A. Observation: A downspout discharges roof water onto the driveway. (See photo #9)

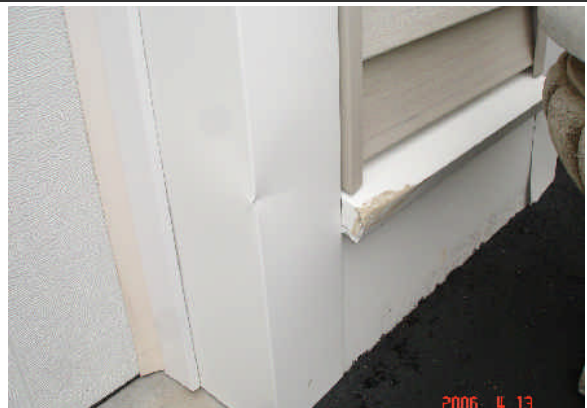
Photo #33

**Observation:** The home has vinyl siding identical to the home. A piece of metal trim wrap is dented, as seen to the right side of the left overhead door. The adjacent water table trim is also patched. (See photo #33)

**Analysis:** Slight abuse is exhibited. Repair is optional.

**Recommendation:** Hire a vinyl siding contractor to install replacement materials as elected.

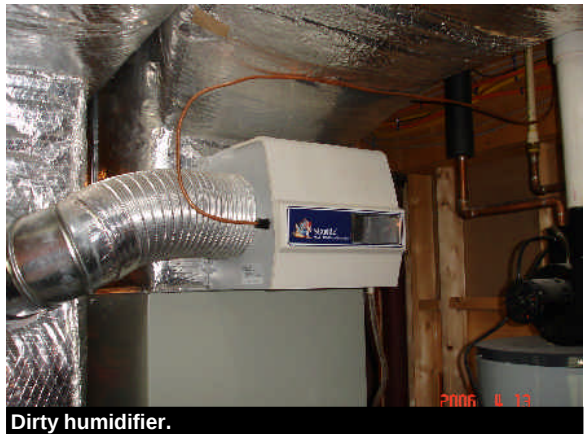
A. Observation: The forced hot air furnace in the basement has an attached automatic humidifier that is operational but dirty at this time.

Analysis: Postponed cleaning is evident, maintenance is needed NOW. This appliance should be cleaned monthly for health reasons as they can be a breeding ground for bacteria. Be advised that a humidifier may shorten the design life of the furnace heat exchanger due to excess moisture and resultant corrosion.

Recommendation: Clean the appliance as required and establish a monthly schedule. I advise that the humidifier be removed for health reasons and for a longer lived furnace.

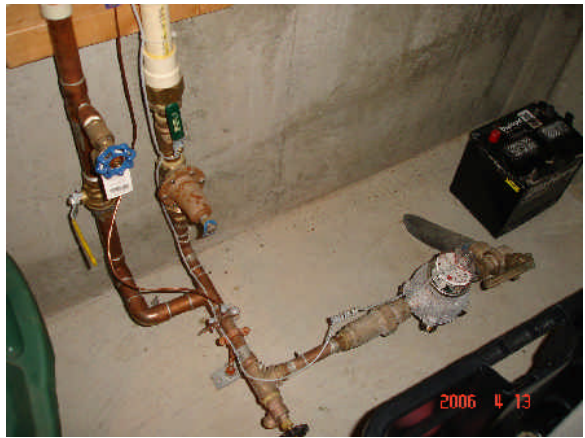
Observation: The home has a modern plastic water service pipe.

Analysis: This is a desirable and corrosion resistant type of water service piping material that is now often used in place of copper.

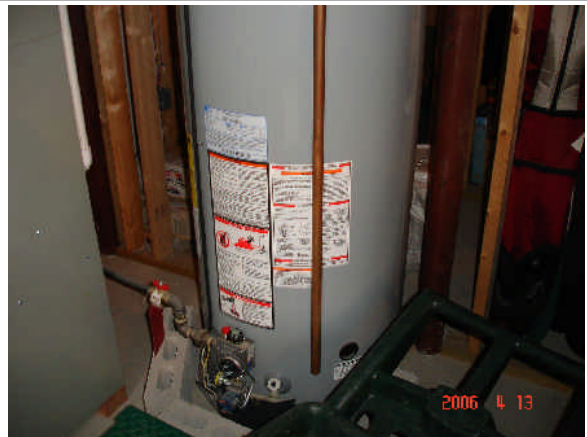
### APPROXIMATE CAPACITY:

50 gallons capacity.

Observation: As indicated by the data plate, the water heater appears to be approximately 3 years old, and has a posted 6-year warranty:

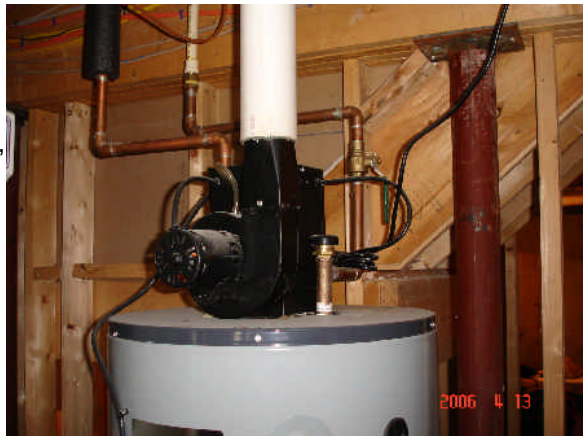
\* **FUNCTIONAL** where *readily accessible*. The required automatic safety devices appear visually **FUNCTIONAL** as designed to protect the hot water systems & components from excessively high or low pressures & temperatures, excessive electrical current, loss of water, loss of ignition, fuel leaks, fire, freezing, or other unsafe conditions. (Controls are NOT tested.)

**SAFETY ALERT:** The water heater has a draft inducer fan and a PVC direct outside wall vent. Outside wall vents can be blocked by snow, causing deadly carbon monoxide to backup into the home. Be sure to remove snow from such vents and install carbon monoxide detectors in the home for added safety.

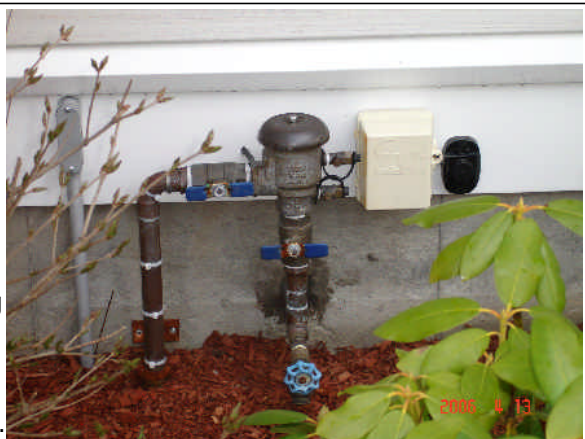
Analysis: **DISCLAIMER - the inspection of this system is EXCLUDED from this report as it is buried and not accessible for visual evaluation - conditions are undetermined.**

Recommendation: Prior to purchase, you should ask the owner to demonstrate the use of the system, including timers, valves, sprinkler heads, maintenance etc. Be sure to ask where the water pipes are buried so that they are not damaged during future landscaping or gardening. I advise that you hire a sprinkler system tradesman to winterize the system each year by blowing high pressure air through the

lines to prevent freeze-ups and other steps as required, and then to restore the system in the Spring.

**NOTICE:** Each zone or the main manifold of the sprinkler system must be protected by an antisiphon device known as a vacuum breaker. A vacuum breaker prevents back-flow of potentially contaminated water from the lawn sprinkler heads to the potable water supply. The vacuum breaker must be at least six inches above the highest sprinkler head.

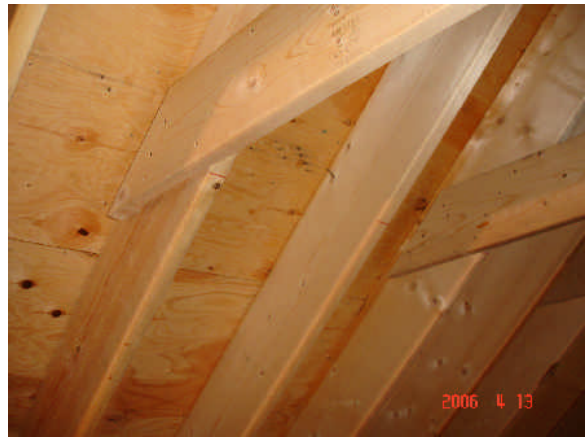
Functional wood, 2 x 10 rafters and plywood decking.  
(See photo #52)

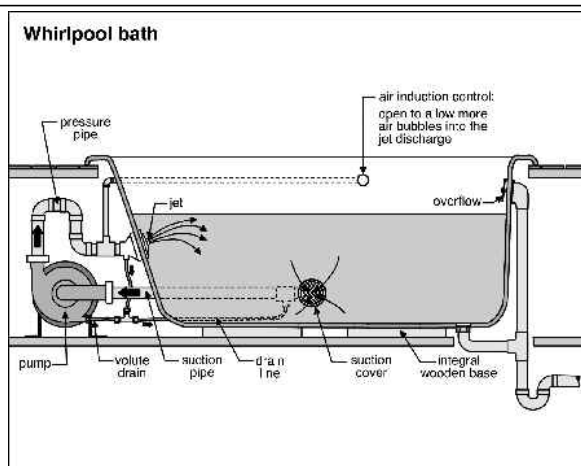
**NOTICE:** The following HydraBaths brand suction guards have been recalled due to openings exceeding 1/8 inch which can cause hair entrapment & drowning:  
# 20313X, # 2031XX and # 203. A safe suction cover will have (ANSI or IAPMO listed or UL listed) embossed on the cover and will rest flat against the tub wall leaving no gap greater than 1/16 inch.

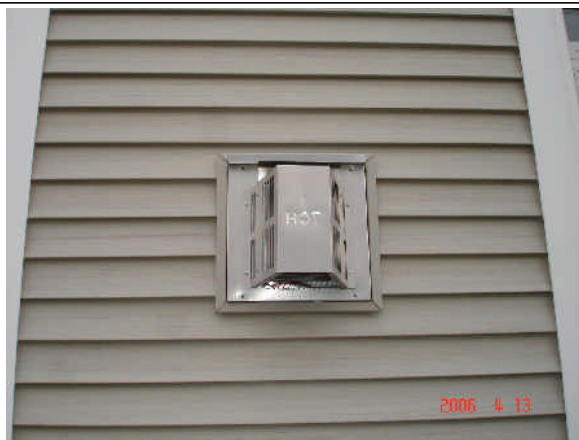
Observation: No visible fireplace problems observed where *readily accessible* at time of inspection. The appliance responded to a remote control device, the gas burner ignited and combustion gases were vented outside through the direct wall vent. (See photo #25)
